Rituals of the Past

The Nature of Ritual Space at Chavín de Huántar

JOHN W. RICK

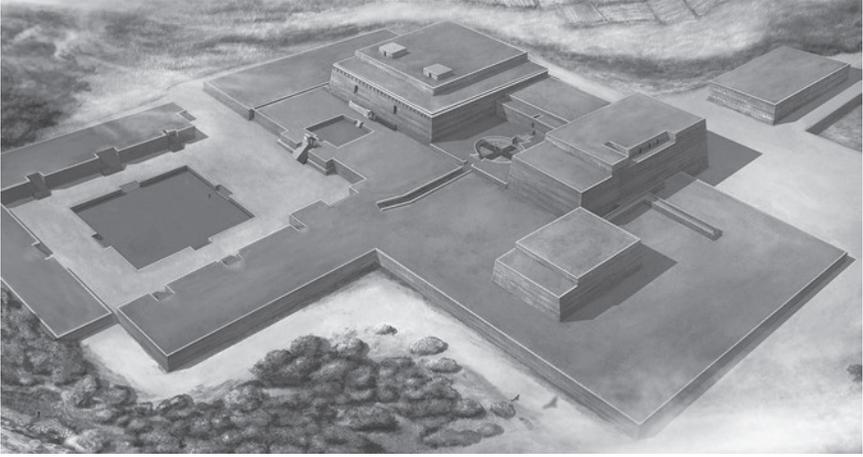
FIGURE 2.1. *Current interpretation of the architectural layout of Chavín de Huántar at about 600 BC cal. Art by Miguel Ortíz.*

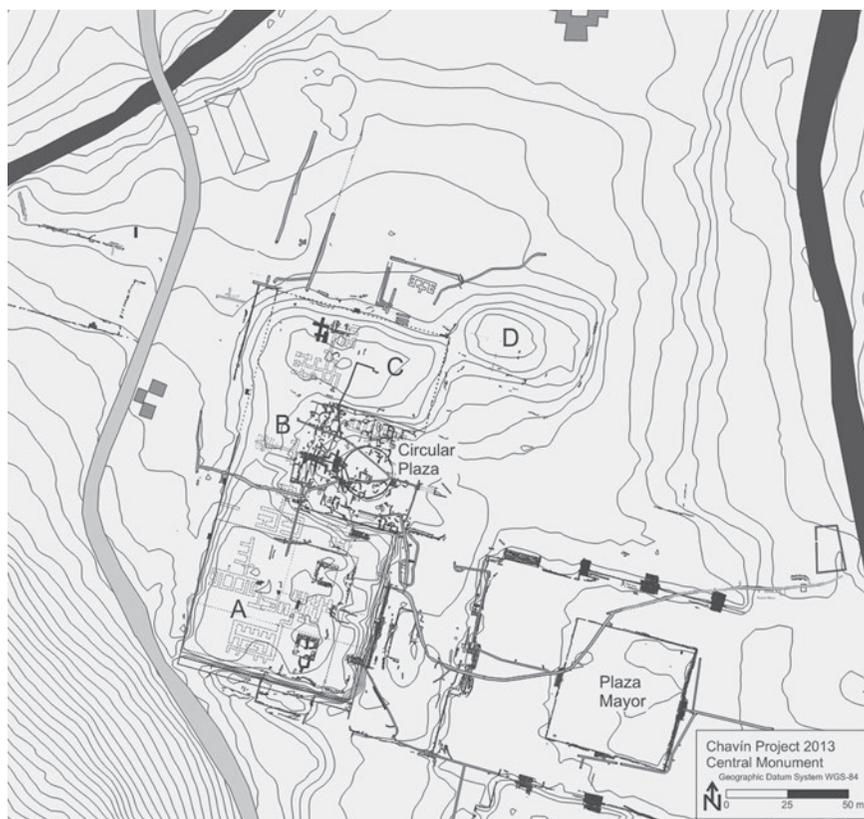
FIGURE 2.2. Map of relevant parts of the monumental core of Chavín de Huántar, showing plazas, major buildings A–D, and locations mentioned in the text

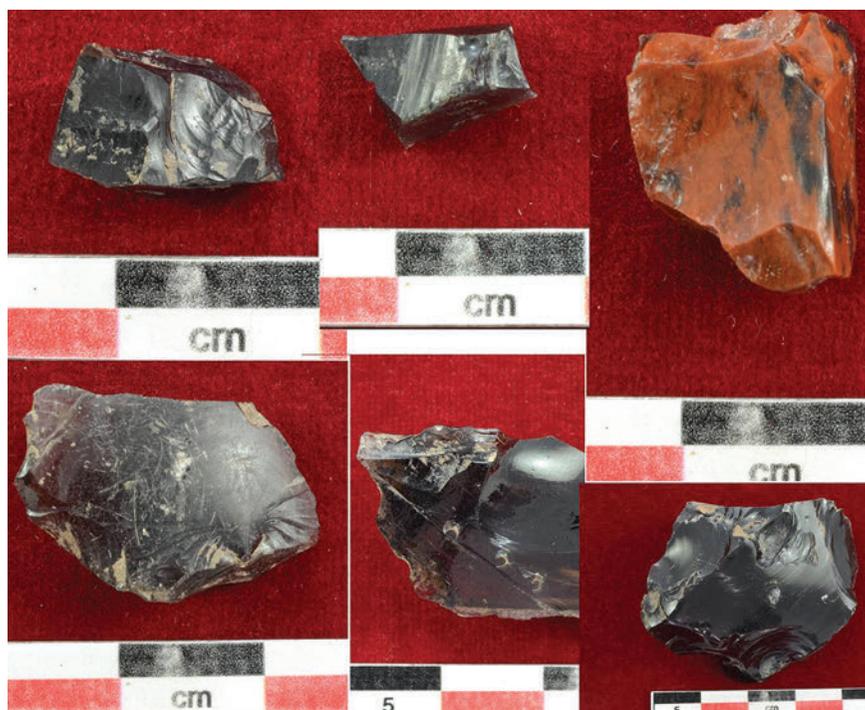
FIGURE 2.3. *Samples of smashed, hammered, and scratched obsidian angular debris illustrating intentional destruction of this material in a number of Building C contexts*

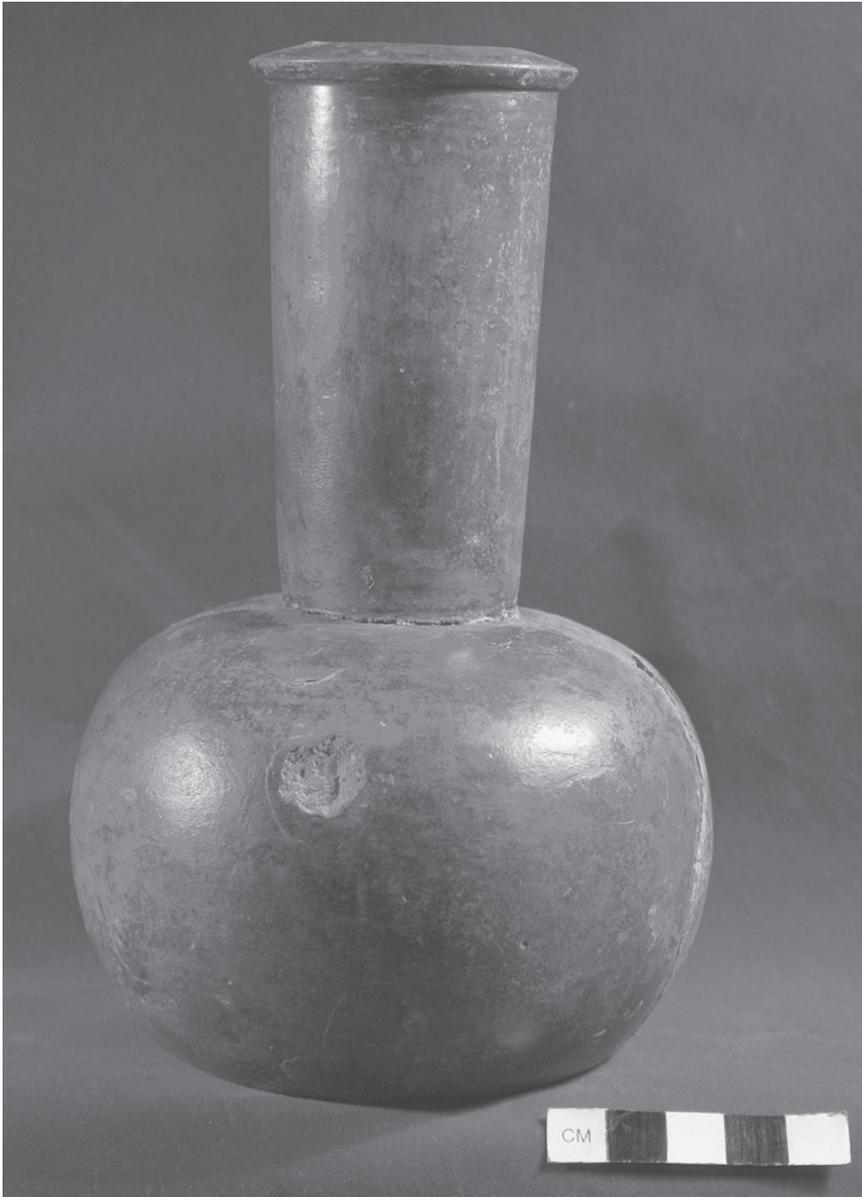
FIGURE 2.4. *Rare intact example of sacrifice ware found in a Building C subterranean canal below a vertical chimney, illustrating the striking form, fine but not highly polished surface treatment, and total lack of evident decoration typical of this category of ritual material*

ceramic that is not highly polished or decorated. Since this 2001 field season discovery, we have become accustomed to finding this ware in situations that seem to imply ritual, particularly sacrificial contexts. If accompanied by other ceramic forms, they are always among the most highly decorated of the Chavín pottery variants. In this pit, the pottery was found in distinctively large fragments—the breaks were fresh and sharp, and the vessels themselves showed little or no signs of wear, as if they arrived at this location brand-new and were broken by perhaps one simple, intentional act. The condition of this pottery seems similar to much larger sacrificial contexts associated with later Wari period sites (Cook 1984–1985; Isbell and Cook 2002) and may represent a less structured but still highly organized series of ritual acts, perhaps related to dedicatory or feasting behavior.

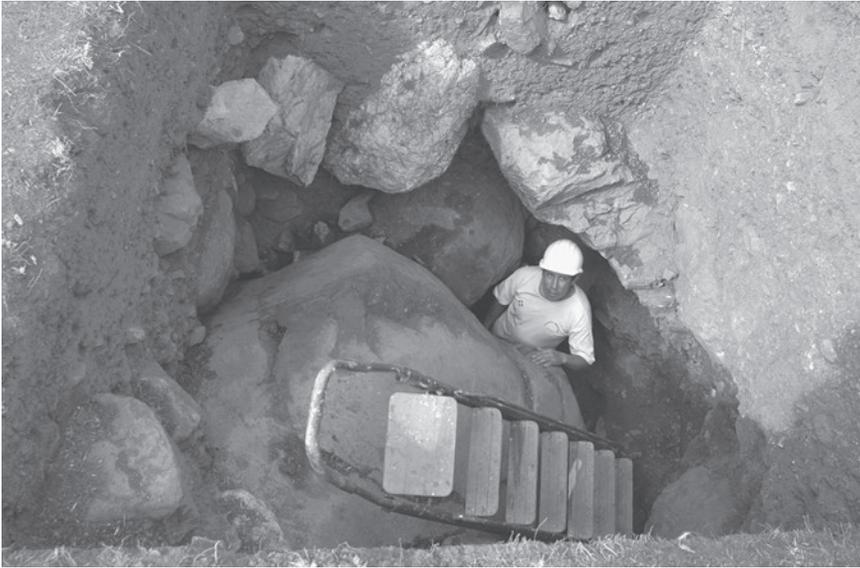
FIGURE 2.5. Exploration of deep pit below the floor of the Plaza Mayor, capped by a huge spalled and burned boulder. Pit extends at least 2 m below the base of the boulder; layers of plaza foundation construction including sizable boulders are visible in profile.

A second geophysical anomaly was detected toward the northwest corner of the Plaza Mayor in 2009, which upon investigation proved to be a similarly huge river boulder again lying just below the original plaza floor and similarly burned on its surface, as evidenced by localized fire-reddening and heat spalling (figure 2.5). In this case, clear evidence was found of a pit, measuring approximately 3 m in diameter and closely enclosing the large boulder, which

extended downward for more than 3 m. Excavations around the boulder but within the pit found increasingly loose soil that eventually entered under the rock, but at a depth of greater than 4 m it became dangerous to work because of the overlying multi-ton boulder, and excavation was suspended. Little material of note came from the pit fill, but close to the maximum depth of our excavation we found a linear arrangement of five approximately 25 cm rounded stones of brilliant colors: red, mustard yellow, white, gray, and black.

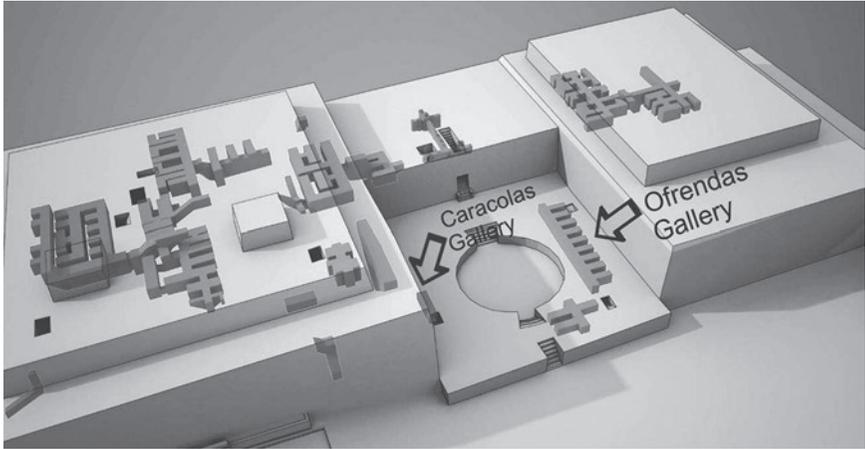
FIGURE 2.6. Location of galleries mentioned in the text and general gallery distribution in Buildings A–C. Modified from graphics courtesy of the Rietberg Museum (Zurich, Switzerland), and ArcTron 3D.

As most galleries were apparently cleaned out long ago, there are few opportunities to find intact deposits; one of the exceptions was the Ofrendas Gallery (figure 2.6), whose contents turned out to be surprisingly intact (Lumbreras 1993, 2007). Ofrendas suggests that some galleries may have functioned to receive offerings that were so extensive and covered so much floor area that it

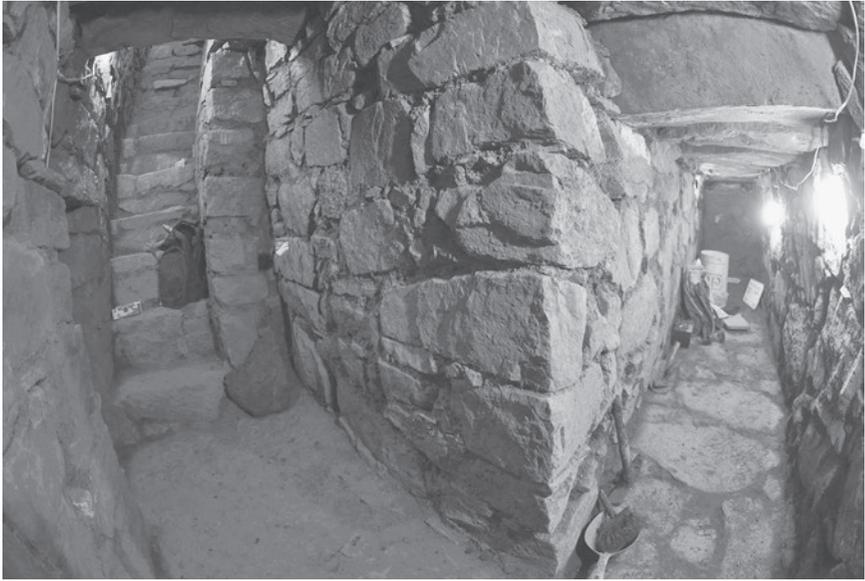
FIGURE 2.7. *Segment of Rocas Canal just west of the Circular Plaza, in original condition. Note the flagstone floor and formal staircase entrance. Canal continues to the left.*

Among the most notable aspects of the canal are the multiple formal entranceways into it (figure 2.7). These entranceways take the form of staircases and short gallery-like passages that occur, at times in pairs, in what seem to be strategic locations adjacent to plaza areas and, notably, at the joining of canal segments. While the staircases are not spacious in character, their dimensions

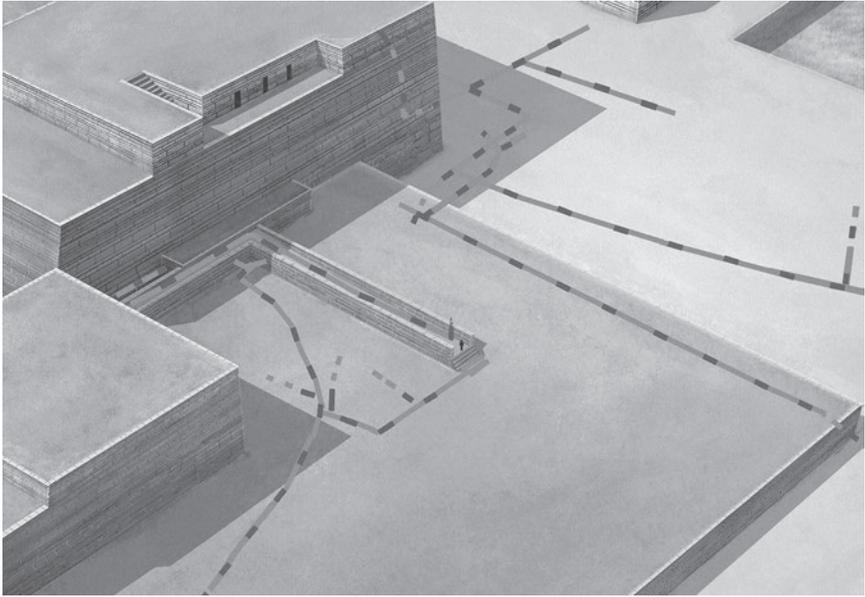
FIGURE 2.8. *Known canals in the north esplanade of Building C as of 2013. These systems represent a small percentage of the likely total of canals underlying Chavín surfaces in this area. Supply canals come from the top right area; drainage extends down to the Mosna and Wacheqsa Rivers to the north and east, respectively.*

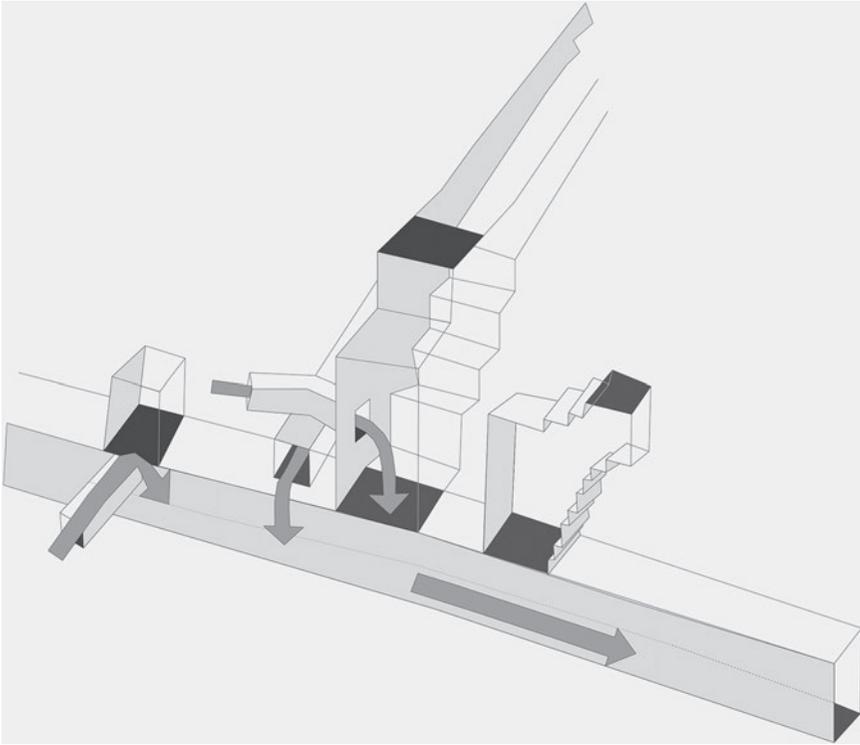
FIGURE 2.9. *Isometric drawing of Canal CE2 of the north esplanade of Building C, showing formal staircase entrances and secondary canal intersections. An important high-energy canal with fountain-like drop into the primary canal is indicated by the descending arrow.*

These canals repeat the same basic theme of the Rocas Canal—entranceways, sometimes paired; intersections of canals, frequently at staircase accesses; and clear concentrations of sacrificed elaborate, high-status materials in precisely these locations. A new theme, however, is the presence of very small-volume surface canals, either open or covered and just below ritual use surfaces. Most striking, these canals are frequently taking water toward Building C rather than away from it and are routed toward the base of the main Building C facade. After bringing water to these key areas, they seem to drop their water down to a lower canal level through short vertical chimneys. The water is then carried away from Building C (or the monumental core) toward the Mosna or Wacheqsa Rivers, often passing entranceway/canal juncture/sacrificial contexts (figure 2.9).

Second, we can now start to more clearly recognize the pattern of canal junctures in which a larger principal or trunk low-slope canal is joined by a smaller-volume but rapidly descending high-energy tributary, which tends to be a supply canal rather than a receiver or drainage canal. Interestingly, these smaller canals always seem to enter the larger canals from the left side, looking downstream along the principal channel. In at least one case, the high-energy subsidiary approaches from the right side, crosses over, and then drops into the main canal, seeming to indicate special effort expended to achieve this right-side entrance. It is notable that this is the pattern of the meeting of the Mosna and Wacheqsa Rivers, which consists of a principal larger-volume and lower-energy channel (Mosna), with the lower-volume higher-energy Wacheqsa
